Service Bulletin

SUBJECT: Service Update for Inventory and Customer Vehicles Underbody Appearance Expires with Base Warranty

MODELS: 2014 Chevrolet Silverado 1500 2014 GMC Sierra 1500

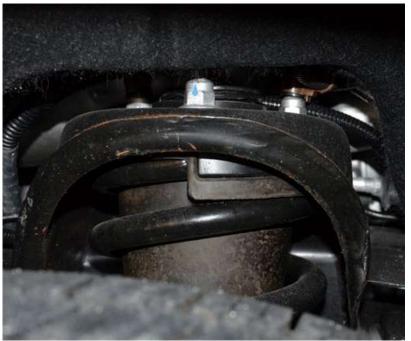
• Front spring mounts (visible through wheelhouse)

No Repair Required

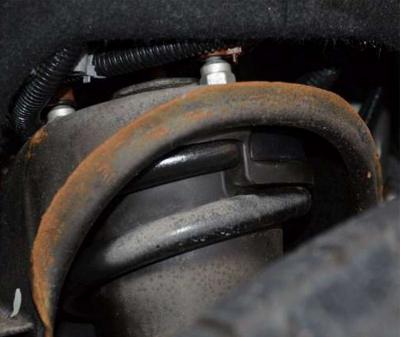
3686529

Repair Required

- 1. Any loose rust or coating should be wire brushed off.
- 2. Using a rag and general purpose adhesive remover, wipe down the affected repair area.
- 3. For the front spring mounts, frame and body mounts, apply a coat of Daubert Nox-Rust® P/N X-121B "One Coat Rust Preventative Coating" (aerosol), or equivalent.
- 4. For the rear axle assembly and rear shock mounts, apply a coat of Lloyds Kryptonite Metal Treatment P/N 36502 Life Long Rust Protection (14 ounce aerosol), or equivalent.

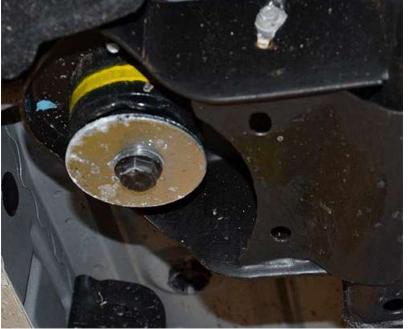
• Body mounts (visible underneath door(s))

No Repair Required

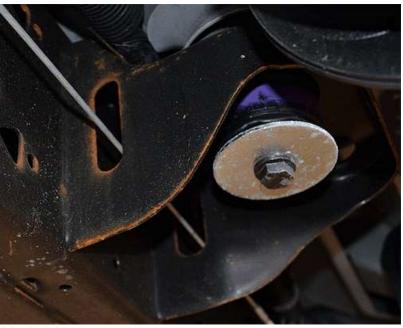
3686508

Repair Required

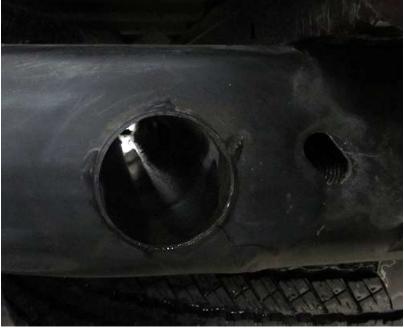
Frame and flanges (visible through wheelhouse and underneath door(s))
No Repair Required

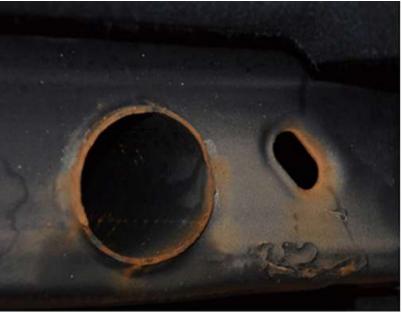
3687196

Repair Required

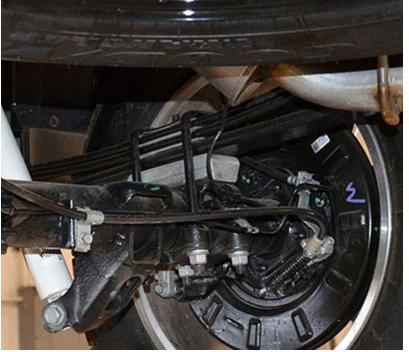
• Rear shock lower mounts

No Repair Required

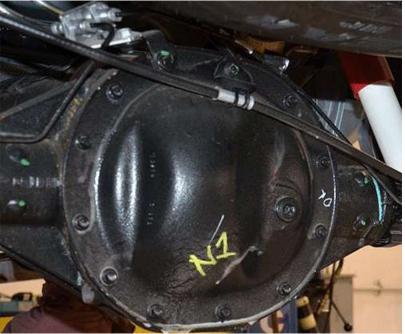
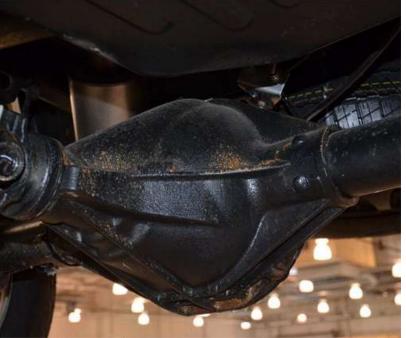
3686524

Rear axle assembly
No Repair Required
